Manhole Inspection Summary

Manhole # S57I__015MH

Insp Date: **7/2/08 9:23 AM**

Location Address: **3900 eastern ave**

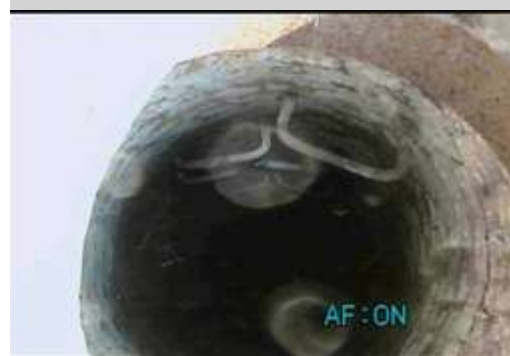
Defect 2

channel debris

corroded steps

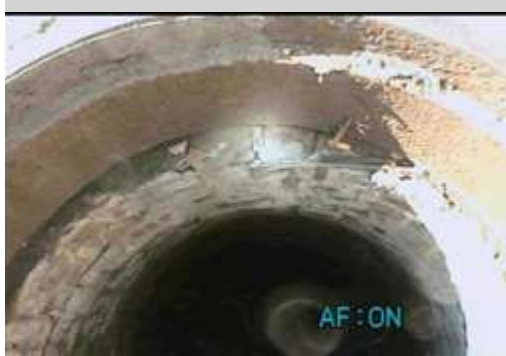
Defect 1

offset

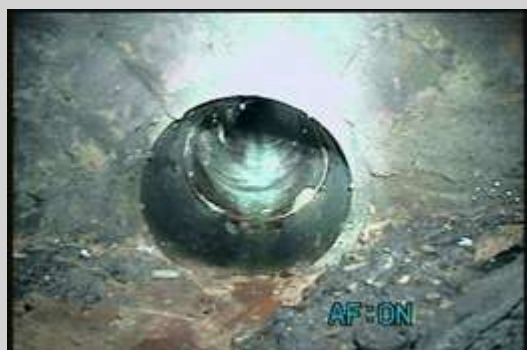
12 O'Clock Outflow

8 in. Circular Gravity Sewer
Pipe Out @ 12 O'Clock
